Confidential Inspection Report

1108.
Inspection Date: May 17, 2010 11:00 AM.
Client:

Inspection Site:

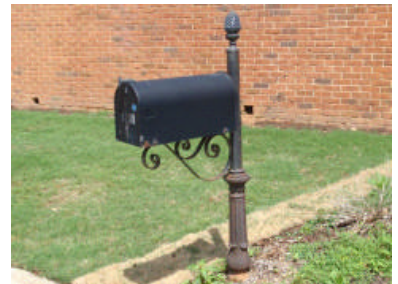
Mailbox Noted: Yes - There is a mailbox on-site. It is functional and at an acceptable height. The pick up mail flag is missing.

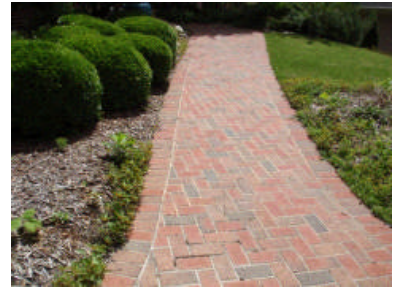
Walkway Condition:

Satisfactory - The walkway surface material is in satisfactory condition with only normal deterioration noted.

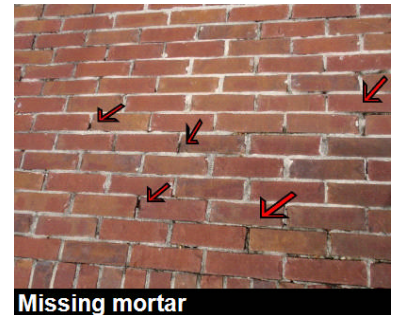
Entryway Stoop:

Attention Needed - The entryway stoop needs some minor repair in order to defer deterioration. The mortar between the bricks appears to be becoming missing in some areas. recommend having a licensed concrete professional remove and point the areas with new mortar.

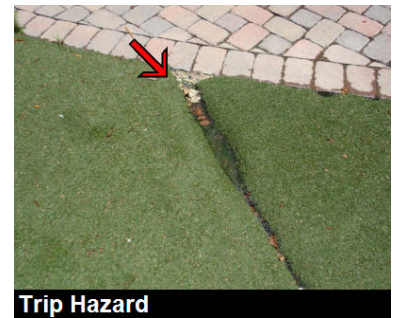
Slab Condition:

Attention Needed - The slab needs repair in order to prevent further deterioration. There is a trip hazard. Recommend having a licensed concrete professional make repairs.

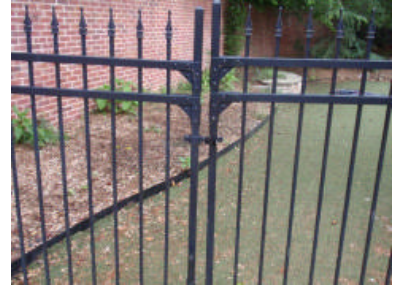
Attention Needed - The gate or latch hardware needs repair to function as intended. The gate requires that both gates be moved in order to open and close the gates. Recommend having a licensed gate professional make repairs.

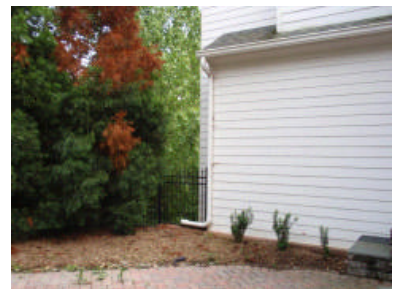
Action Necessary - The run-off water above the retaining wall needs to be redirected as there is evidence of deterioration or movement that appears to have been caused by water. Mainly close to the house behind the grill area, it appears that water can stand and saturate the area causing moisture to get into wall at the corner basement wall. Recommend having a licensed landscape professional put weep holes in the retaining wall. This will help relieve the pressure and probably exclude the water from getting in to the wall at the basement corner. Weep holes should be roughly 4 inches in diameter and not more than 10 feet apart.

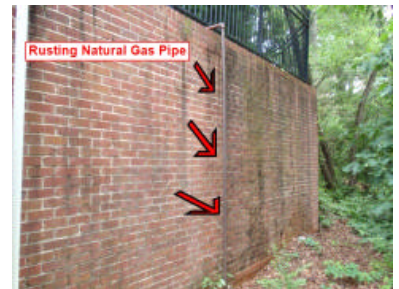
Black Iron Pipe. Within the house the black iron pipe is good. Outside the black iron pipe supplying natural gas to the pool is rusting. Recommend removing the rust and coating the pipe with rust preventative paint.

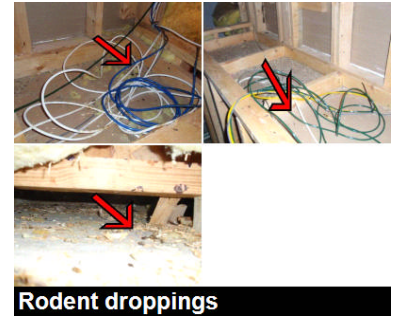
Yes - There is visible evidence of rodent infestation on the basement level. Mainly behind and on top of the home theater screen and along that back wall under the kitchen & laundry area. Recommend having a licensed pest control professional remove droppings and eliminate rodents and put an exclusion plan into effect.

Rodent droppings

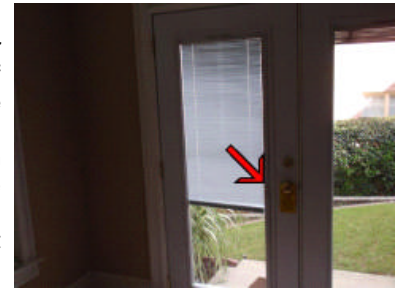
Attention Needed - The outside entry door to the walkout basement needs some minor adjustment or repair. The doors were not opened at the time of inspection as the keys available did not work in the available lock. Additionally the between the glass mini louvers on the operating door did not perform as expected they did not lower all of the way. The slider is no longer completely attached to the movement mechanism. Also the semi permanent door is not secured as expected. Recommend having a licensed carpenter make adjustments as necessary. There is a deadbolt installed on the entry door, and it is operational. This is a recommended safety feature.

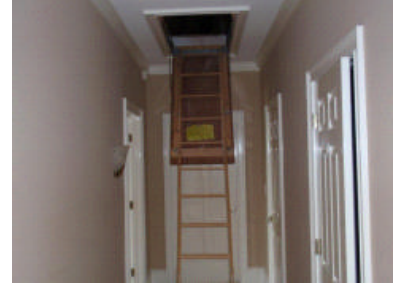
For improved energy efficiency, it is recommended that the pull down attic ladder have perimeter weather-stripping and insulation installed to reduce heat loss and heat gain at this location.

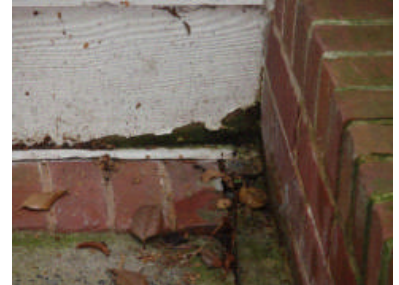
Attention Needed - The exterior siding material or finish is in a condition that requires minor repair to prevent further deterioration. Exterior man en entry door to the kitchen hallway the siding at the ground level is rotten.

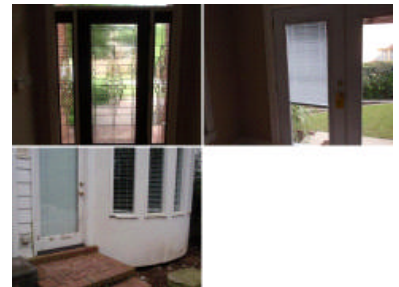
The noted door(s) is located Front door. It appears the front door does not seal properly at the top. Recommend having a licensed carpenter make repairs. The back door appears to be soft wood and in need of replacement. recommend having a licensed carpenter make repairs. The basement french doors did not operate at the time of inspection. They were locked shut and did not appear to be in good condition. Recommend having a licensed carpenter make repairs.

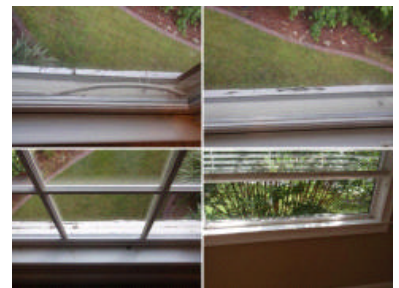
There are approximately 53 windows in the house. It appears that about 35% of the windows are in need of repair. Several window sills are rotten, have soft wood or are in need of replacement. The pladium window at the front of the house at the landing of the upstairs stair case the bottom of that big window appears to be in need of replacement. recommend having a licensed window person make repairs.

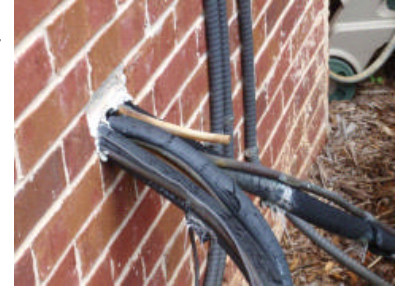
Action Necessary - The insulation wrap for the suction line to the condenser/compressor is either missing or needs replacement. This condition affects the efficiency of the cooling system.

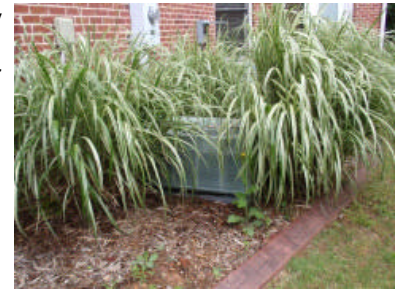
Action Necessary - Conditions exist which severely restrict the air around the condenser cabinet. Action is recommended to minimize the air restrictions within 4 feet of the cabinet. Recommend removing the saw grass around the units.

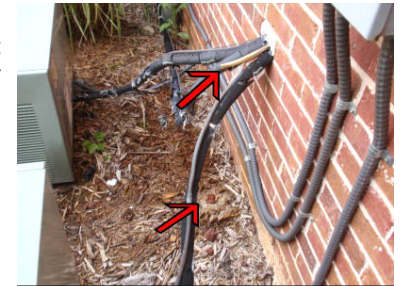
Attention Needed - There is a condensate drain line installed, but attention is recommended so that it will drain the condensate from the evaporator condensate tray into the condensate drain line.

Condensate Discharges too close to house

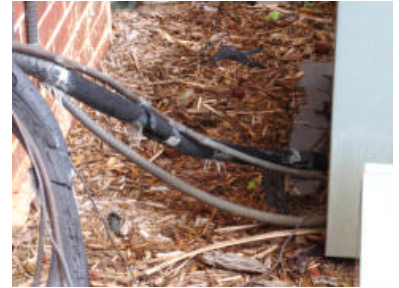
Action Necessary - The insulation wrap for the suction line to the condenser/compressor is either missing or needs replacement. This condition affects the efficiency of the cooling system.

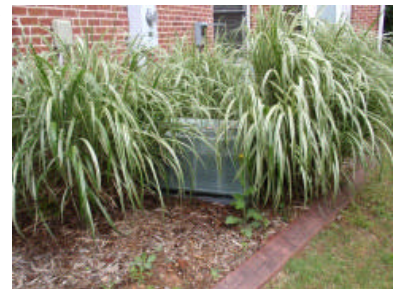
Action Necessary - Conditions exist which severely restrict the air around the condenser cabinet. Action is recommended to minimize the air restrictions within 4 feet of the cabinet. Recommend removing Saw grass.

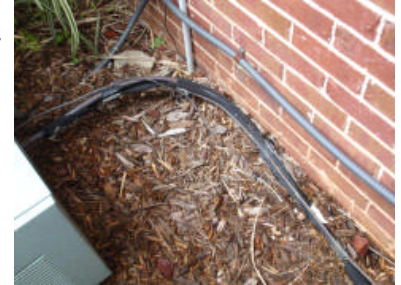
Action Necessary - The insulation wrap for the suction line to the condenser/compressor is either missing or needs replacement. This condition affects the efficiency of the cooling system.

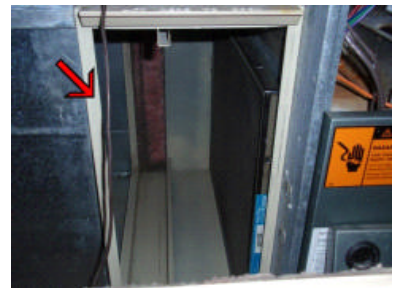
Filter Size: 20" X 25" X 1". The unit has a "SpaceGuard High Efficiency Air Filter" which can do a superior job of cleaning air if the unit is installed and installed properly. Recommend having a licensed HVAC professional replace the filter.

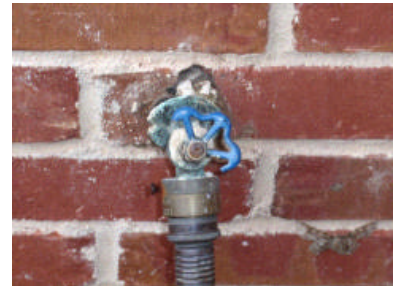
Exterior Hose Bibs Functional: **Attention Needed** - At least one of the exterior hose bibs either leaks or did not turn on during the inspection. The hose bib at the back of the house has a broken handle. Recommend replacing the handle.

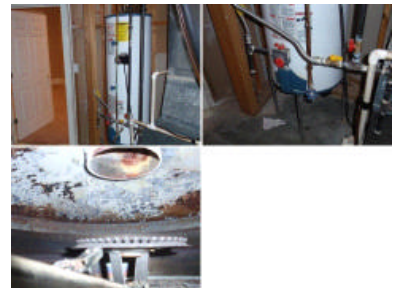
Brand - RHEEM; Model # 41V50; Serial # RHNG1297A25129 ; Manufactured approximately 1997. The average service life for a water heater is 10 - 12 years. The water heater appears to be at or near the end of its economic life. Although it is functional today, you should plan for its replacement.

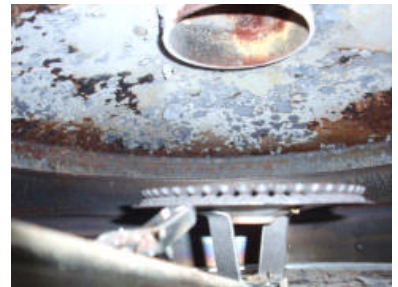
There is rust on the underside of the tank.

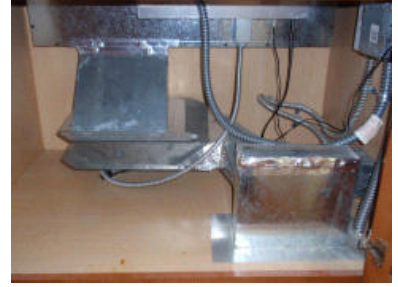
Brand - General Electric; Model # JUB66W1BB; Serial # FT822182C . Rather than a range hood, there is a Jenn-Air Type range top installed. This unit has a ducted vent fan system installed. The unit is not functioning as intended. The unit did not operate when start button was depressed. Recommend having a licensed electrician make repairs as necessary.

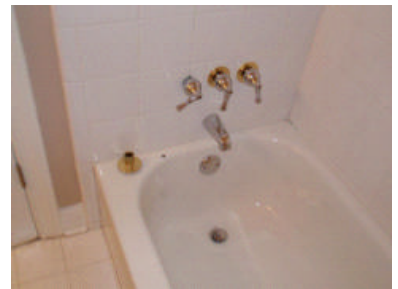
Attention Needed - The caulking in the water contact areas appears to need attention. Damage may result if not corrected. Around the tub the grout is missing or cracked. Recommend having a licensed tile professional remove grout, replace and seal.

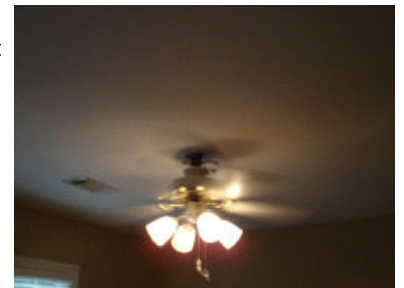
<i>Entry Door:</i>	Satisfactory - The entry door on the master room is as I expected, and it is functional.
<i>Closet:</i>	Satisfactory - The closet is functional and of average size. The closet is lighted.
<i>Walls:</i>	Satisfactory - The walls in the room appear to be satisfactory.
<i>Ceiling:</i>	Satisfactory - The ceiling is functional and as I expected.
<i>Ceiling Fan:</i>	Attention Needed - The ceiling fan installed in this room appears to need some adjustment. The mount cover is not attached and the fan wobbles while in operation. Recommend having a licensed electrician replace.
<i>Floor:</i>	Satisfactory - The floors are in satisfactory condition. The floor covering material is carpet.
<i>Windows:</i>	Satisfactory - The windows and associated hardware in this room are all satisfactory. Attention Needed - The screen for this window needs repair.

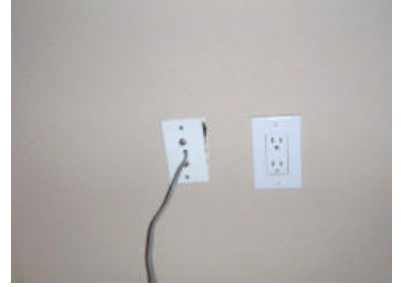
Yes - There is a telephone jack installed in this room. It may or may not be functional. It has broken sheet rock behind it.

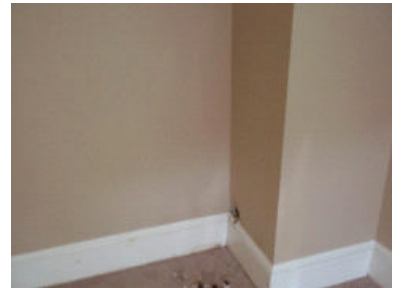
Action Necessary - There is a condition in the wall sheeting that needs to be repaired. There is at least one area that appears to have moisture behind the wall as evidenced by the water marks and broken out piece of sheetrock.

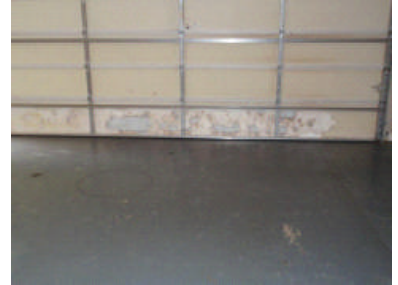
Overhead Door and Hardware Condition: **Attention Needed** - The overhead door needs some minor repair. the bottom panels on both doors are missing insulation. Recommend having a licensed overhead door professional make repairs.

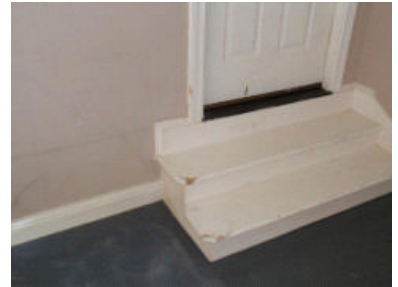
Fire Rated Entry Door to Structure: Yes - There is a fire rated door separating the garage from the living areas of the house. It appear the steps to the house have been chewed on.
