Confidential Inspection Report

1108.
Inspection Date: May 17, 2010 11:00 AM.
Client:

Inspection Site:

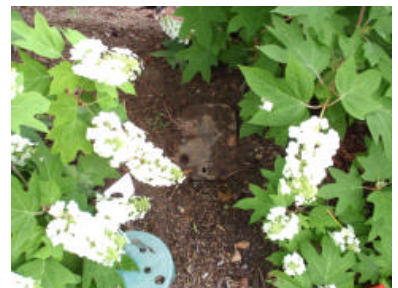
Water Meter Location:

Front yard several feet in from the street.

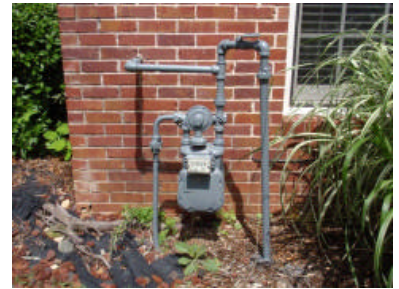
Location of Meter:

A/C side of the house.

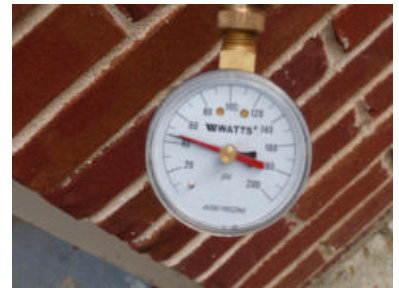
Water Pressure: 45 PSI. Water pressure was checked at an exterior hose bib. Water pressure from 40 to 80 pounds per square inch is considered within normal/acceptable range.

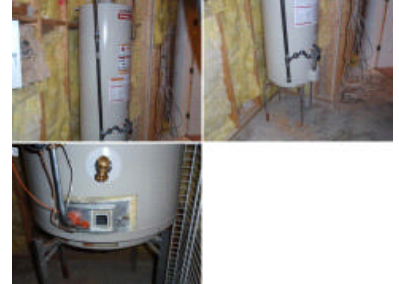
The water heater is the newer FVIR (Flammable Vapor Ignition Resistant) type of tank now required by federal mandate for improved safety in the event of flammable vapor ignition near the water heater. This type of tank has a sealed burner opening at the front and a flame arrestor plate underneath the tank that prevents flames traveling out to the floor in case of flammable spillage at the tank location. If vapor ignition event occurs, a calibrated thermal switch activates to shut down the pilot light and burner. Should this safety shutdown occur, service will be required by a licensed plumber before the water heater can be brought back into service. Because of these safety features, this type of gas water heater can be allowed on the floor of a garage or other location where gasoline or other flammable vapors will be stored, these tanks do not require to be raised 18 inches off of the floor as previously required with older tanks. Due to air flow requirements, this type of tank should not be wrapped with an insulation blanket.

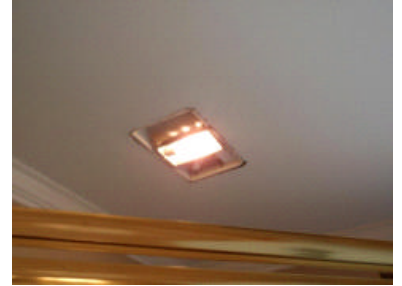
Ventilation Fans: ceramic or glazed tile.
Attention Needed - There is an exhaust fan installed in this bathroom, it does not have a cover.

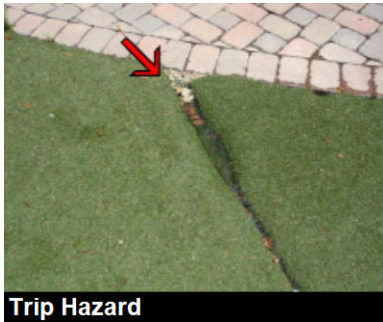
Patio:*B.2: Slab Condition:*

Attention Needed - The slab needs repair in order to prevent further deterioration. There is a trip hazard. Recommend having a licensed concrete professional make repairs.

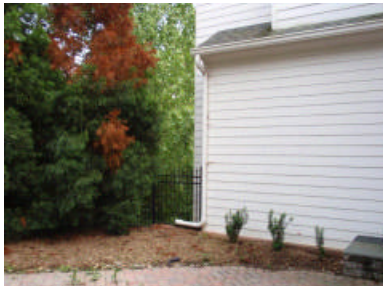
Retaining Walls:*B.4: Water Drainage:*

Action Necessary - The run-off water above the retaining wall needs to be redirected as there is evidence of deterioration or movement that appears to have been caused by water. Mainly close to the house behind the grill area, it appears that water can stand and saturate the area causing moisture to get into wall at the corner basement wall. Recommend having a licensed landscape professional put weep holes in the retaining wall. This will help relieve the pressure and probably exclude the water from getting in to the wall at the basement corner. Weep holes should be roughly 4 inches in diameter and not more than 10 feet apart.

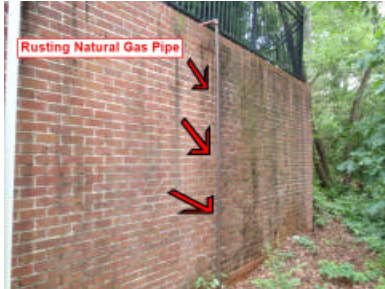
B.5: Gas Line Primary Piping Material:

Black Iron Pipe. Within the house the black iron pipe is good. Outside the black iron pipe supplying natural gas to the pool is rusting. Recommend removing the rust and coating the pipe with rust preventative paint.

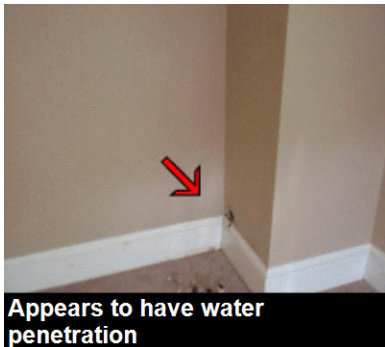
B.6: Evidence of Water Entry in the Basement Noted:

Action Necessary - There is evidence of water entry or damage in the basement level. Back basement room in the corner. There appears to be a section where moisture has entered the house from behind the retaining wall at the grill area. See notes in site "Retaining Walls". recommend having a licensed irrigation specialist make corrections i.e. add weep holes.

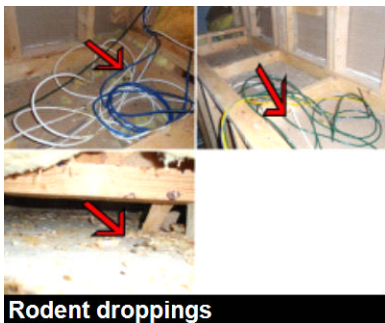
B.7: Evidence of Rodent Infestation:

Yes - There is visible evidence of rodent infestation on the basement level. Mainly behind and on top of the home theater screen and along that back wall under the kitchen & laundry area. Recommend having a licensed pest control professional remove droppings and eliminate rodents and put an exclusion plan into effect.

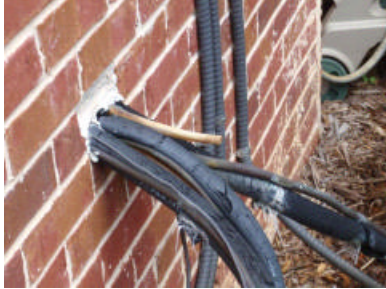
HEATING, VENTILATION & AIR CONDITIONING**Air Conditioning Unit No. 1:****B.11: Insulation Wrap on the Suction Line:**

Action Necessary - The insulation wrap for the suction line to the condenser/compressor is either missing or needs replacement. This condition affects the efficiency of the cooling system.

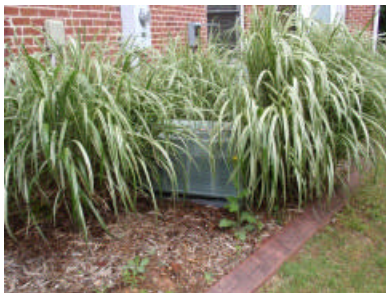
B.12: Condenser Clear of Obstruction:

Action Necessary - Conditions exist which severely restrict the air around the condenser cabinet. Action is recommended to minimize the air restrictions within 4 feet of the cabinet. Recommend removing the saw grass around the units.

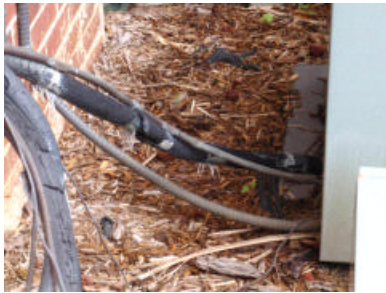
B.13: Insulation Wrap on the Suction Line:

Action Necessary - The insulation wrap for the suction line to the condenser/compressor is either missing or needs replacement. This condition affects the efficiency of the cooling system.

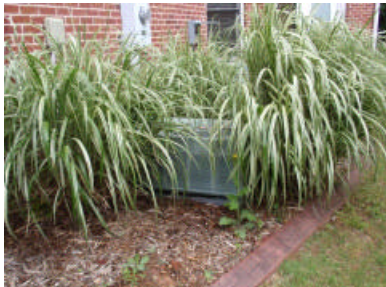
B.14: Condenser Clear of Obstruction:

Action Necessary - Conditions exist which severely restrict the air around the condenser cabinet. Action is recommended to minimize the air restrictions within 4 feet of the cabinet. Recommend removing Saw grass.

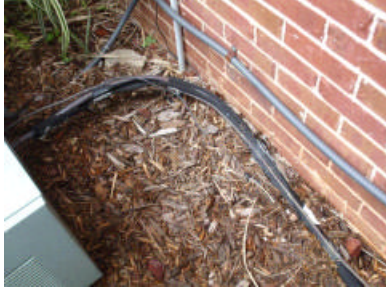
Air Conditioning Unit No. 3:*B.15: Insulation Wrap on the Suction Line:*

Action Necessary - The insulation wrap for the suction line to the condenser/compressor is either missing or needs replacement. This condition affects the efficiency of the cooling system.

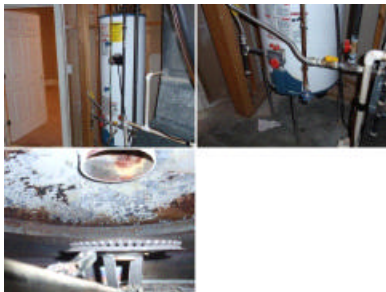
B.26: Model & Serial Numbers:

Brand - RHEEM; Model # 41V50; Serial # RHNG1297A25129 ; Manufactured approximately 1997. The average service life for a water heater is 10 - 12 years. The water heater appears to be at or near the end of its economic life. Although it is functional today, you should plan for its replacement.

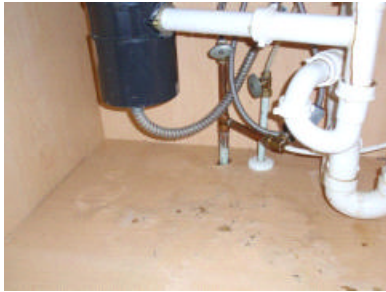
B.29: Food Waste Disposal:

Leaks. Recommend having a licensed plumber make repairs. Satisfactory - The food waste disposal appears to be functional. No food was ground up in this inspection. The inspector was unable to determine if the unit will grind food waste adequately.

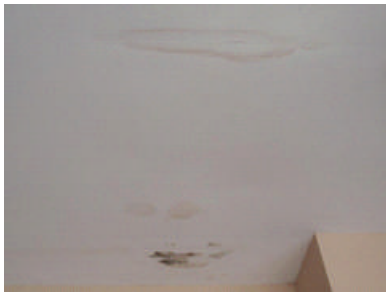
B.32: Tub/Shower Drain:

There is a visible leak under the tub/shower. Services of a qualified licensed plumber are required. **Action Necessary** - A condition exists that calls for immediate action. This shower pan leaks as evidenced by the water spot in the ceiling of the garage. Do not use this shower until repaired. recommend having a licensed tile professional make repairs.

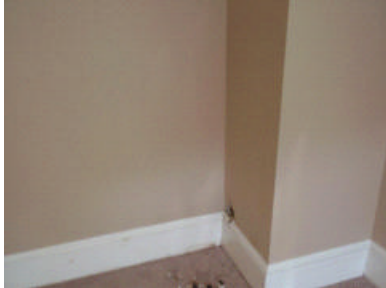
OTHER LIVING SPACESBig Room In Basement:*B.34: Walls:*

Action Necessary - There is a condition in the wall sheeting that needs to be repaired. There is at least one area that appears to have moisture behind the wall as evidenced by the water marks and broken out piece of sheetrock.

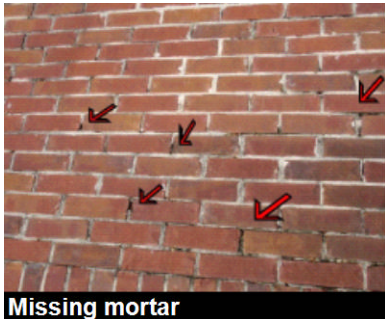
**Paving Condition:****C.4: Entryway Stoop:**

Attention Needed - The entryway stoop needs some minor repair in order to defer deterioration. The mortar between the bricks appears to be becoming missing in some areas. Recommend having a licensed concrete professional remove and point the areas with new mortar.

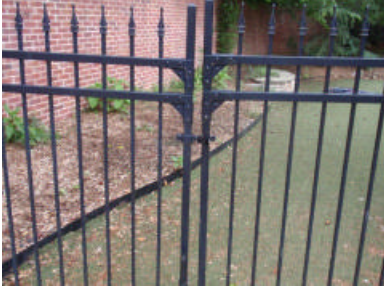
**Fences & Gates:****C.5: Gates and Latches:**

Attention Needed - The gate or latch hardware needs repair to function as intended. The gate requires that both gates be moved in order to open and close the gates. Recommend having a licensed gate professional make repairs.

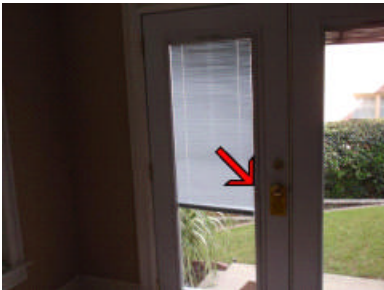
C.8: Outside Entry Doors:

Attention Needed - The outside entry door to the walkout basement needs some minor adjustment or repair. The doors were not opened at the time of inspection as the keys available did not work in the available lock. Additionally the between the glass mini louvers on the operating door did not perform as expected they did not lower all of the way. The slider is no longer completely attached to the movement mechanism. Also the semi permanent door is not secured as expected. Recommend having a licensed carpenter make adjustments as necessary. There is a deadbolt installed on the entry door, and it is operational. This is a recommended safety feature.

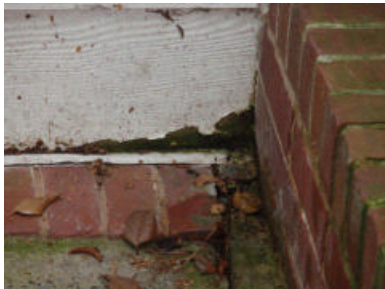
C.13: Siding Condition:

Attention Needed - The exterior siding material or finish is in a condition that requires minor repair to prevent further deterioration. Exterior man en entry door to the kitchen hallway the siding at the ground level is rotten.

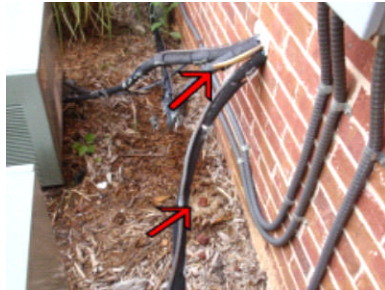
C.20: Condensate Line:

Attention Needed - There is a condensate drain line installed, but attention is recommended so that it will drain the condensate from the evaporator condensate tray into the condensate drain line.

Condensate Discharges too close to house

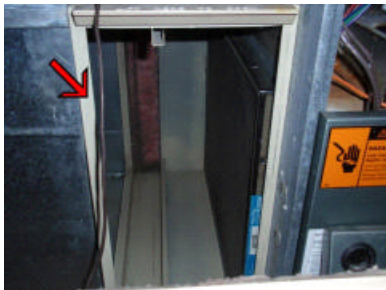
C.25: Filter Size:

20" X 25" X 1". The unit has a "SpaceGuard High Efficiency Air Filter" which can do a superior job of cleaning air if the unit is installed and installed properly. Recommend having a licensed HVAC professional replace the filter.

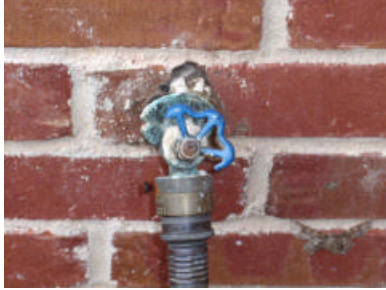
Plumbing:*C.29: Exterior Hose Bibs Functional:*

Attention Needed - At least one of the exterior hose bibs either leaks or did not turn on during the inspection. The hose bib at the back of the house has a broken handle. Recommend replacing the handle.

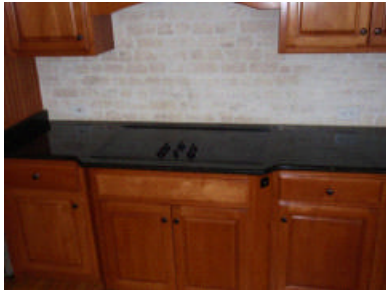
*C.31: Faucet and Supply Lines:*

Satisfactory - Faucets and supply lines appear satisfactory with no leaks noted. There are shutoffs installed for both hot and cold water pipes under the basin. The dish sprayer attachment is not functional it could not turn off the sprayer completely.

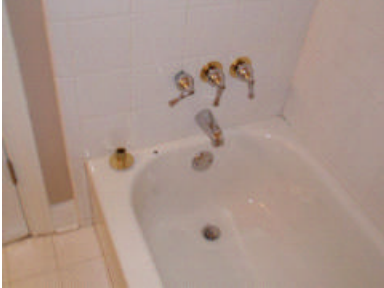
C.34: Caulking/Water Contact Areas:

Attention Needed - The caulking in the water contact areas appears to need attention. Damage may result if not corrected. Around the tub the grout is missing or cracked. Recommend having a licensed tile professional remove grout, replace and seal.

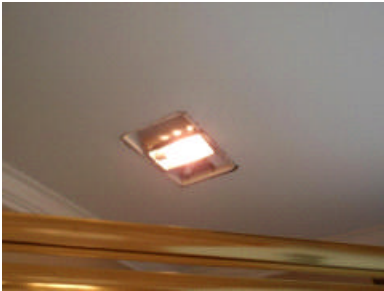
C.35: Ventilation Fans:

Attention Needed - There is an exhaust fan installed in this bathroom, it does not have a cover.

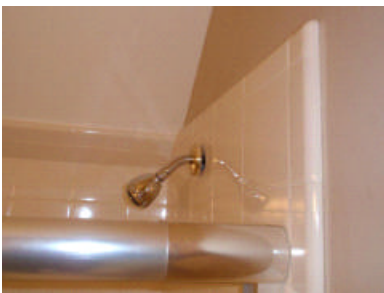
C.36: Tub:

Attention Needed - Steel Tub Needs Repair - The bathtub is a steel material, and it appears to have some rust or chip in the finish. There is no evidence of its leaking at this time. I know of no permanent repair, and replacement will be needed. The Escutcheon Plates (the decorative trim rings around pipe penetrations through walls) are missing.

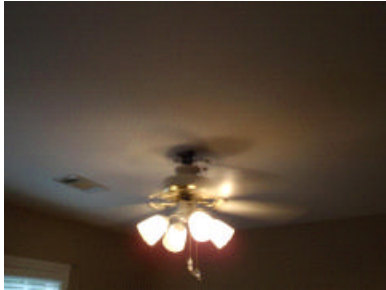
BEDROOMSBedroom #2: Front Of House A/C Side Upper Floor.*C.50: Windows:***Attention Needed** - At least one window or associated hardware in this room needs attention.Bedroom #3: Back Of House Over Garage*C.51: Ceiling Fan:***Attention Needed** - The ceiling fan installed in this room appears to need some adjustment. The mount cover is not attached and the fan wobbles while in operation. Recommend having a licensed electrician replace.

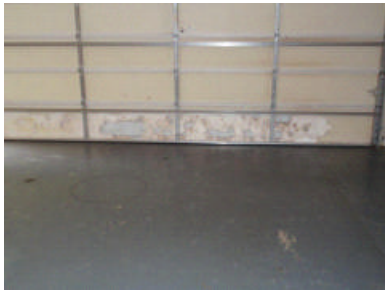
C.65: Overhead Door and Hardware Condition:

Attention Needed - The overhead door needs some minor repair. the bottom panels on both doors are missing insulation. Recommend having a licensed overhead door professional make repairs.
